**OPTICAL INSTRUMENTATION
DATA EVALUATION
OF THE SA-204/LM-1 SATURN IB
LAUNCH VEHICLE**

Technical Report HSM-R302-68

L. F. Dennis
and
W. L. Cardwell

March 8, 1968

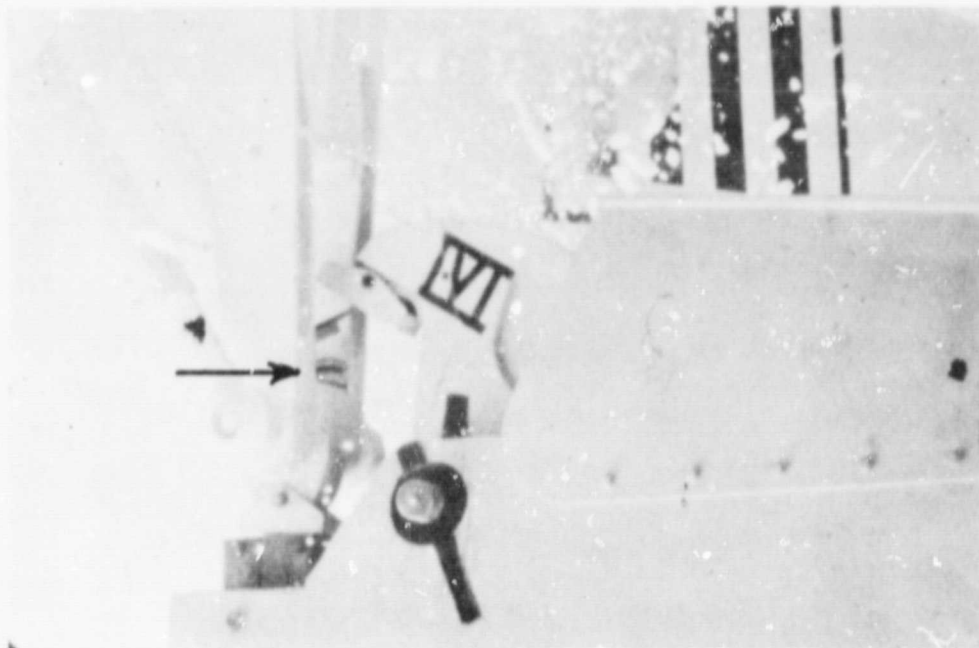
FIGURE 18. HOLDDOWN ARM SHOE ON VEHICLE

Eight cameras were programmed to cover the release of the eight holddown arms. The releases of all eight arms were timed and plotted (Figures 10 through 17). On two arms (II and IV-I), part of the holddown shoe was observed to remain with the vehicle after release (Figure 18). Also, it was noted that two of the vehicle support struts moved laterally just prior to the release of the holddown arms on which the struts were sitting (Figures 19 and 20). These observations were reported to the associated ground support equipment office at Kennedy Space Center.

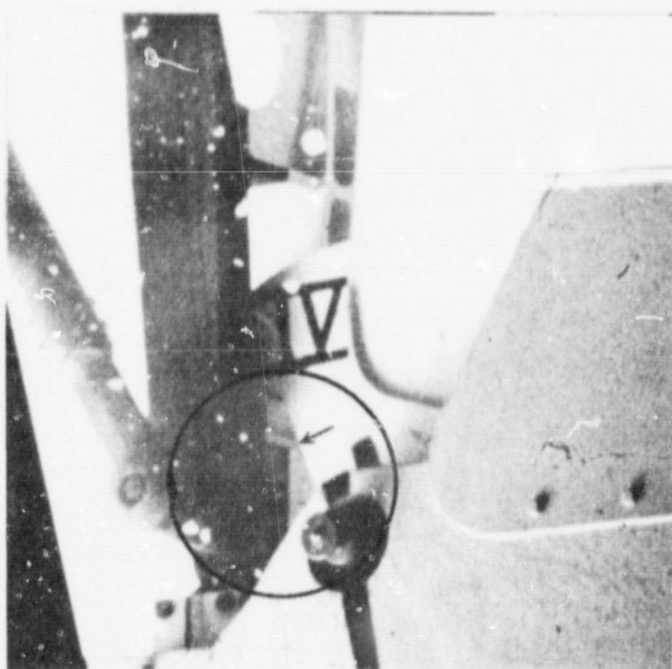
FIGURE 19. VEHICLE SUPPORT STRUT
SHIFT HOLDDOWN ARM IV
BEFORE

Comments: Excellent coverage of release and retraction of the arm. Vehicle holddown leg at fin 4 moved laterally to the inside immediately prior to arm release. No malfunctions were observed. Release of the arm was timed.

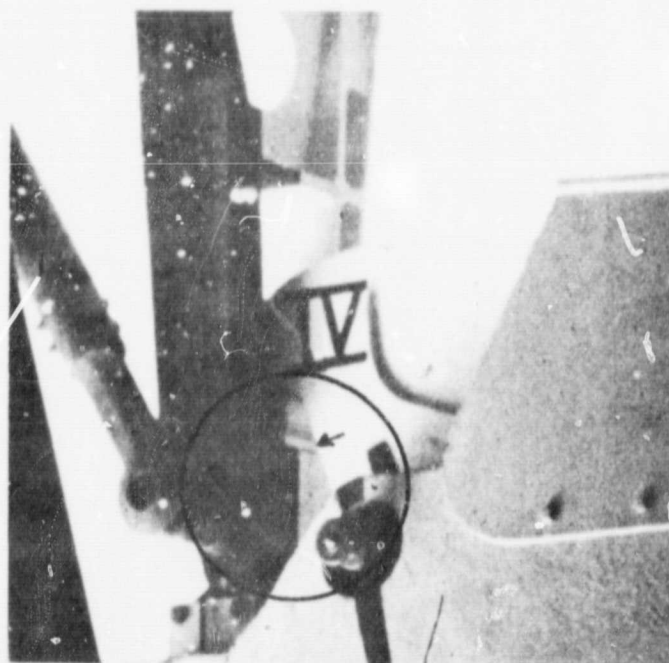
FIGURE 20. VEHICLE SUPPORT STRUT
SHIFT HOLDDOWN ARM II
AFTER

Required Orientation: Holddown arm II release jaw centered in left half of frame for study of holddown arm release action. Holddown arm II is located at 0° AZ. T.
 Comments: Coverage of the release was good. Part of the shoe remains with the vehicle. Some flame and blast impingement upon the LOX mast was observed. Some lateral motion of the vehicle arm was observed.

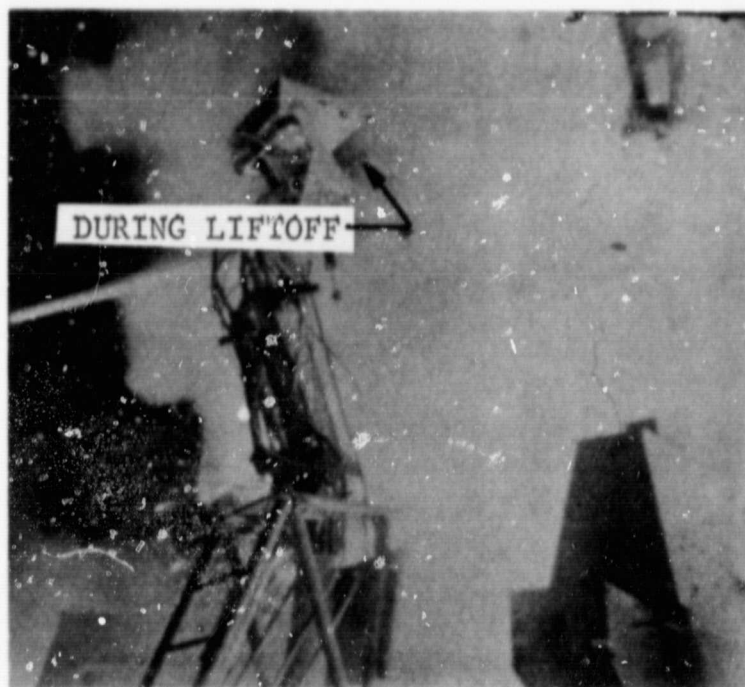
FIGURE 21. SHORT CABLE MAST II DEFLECTOR COVER

Two cameras were programmed to cover the release and retraction of these masts. Both cameras produced technically usable film; however, the field of view was obscured by frost and ice during the time of release and retraction and the retraction of the masts was obtained from another source. The flame deflector cover of mast II fails

Required Orientation: Top of short cable mast II umbilicals centered in upper left quadrant of frame for study of umbilical release and mast retraction.
 Comments: Frost and ice obscure the mast disconnect. Mast retraction was observed. Cover fails to close completely until hit by blast. Flame and blast impingement was observed on short cable mast II and LOX mast. Fin I-II vibration was observed during thrust build-up and after lift-off. Release time of the mast was not determined due to ice and/or frost.

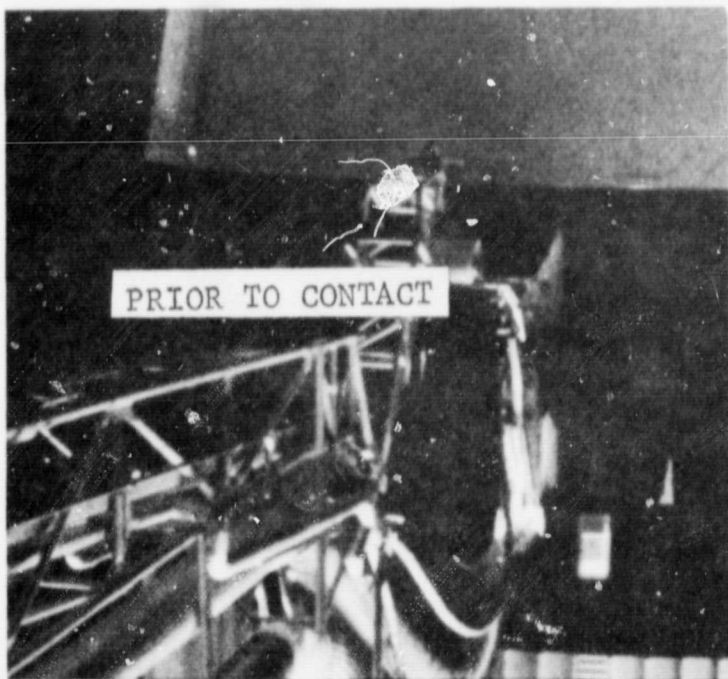
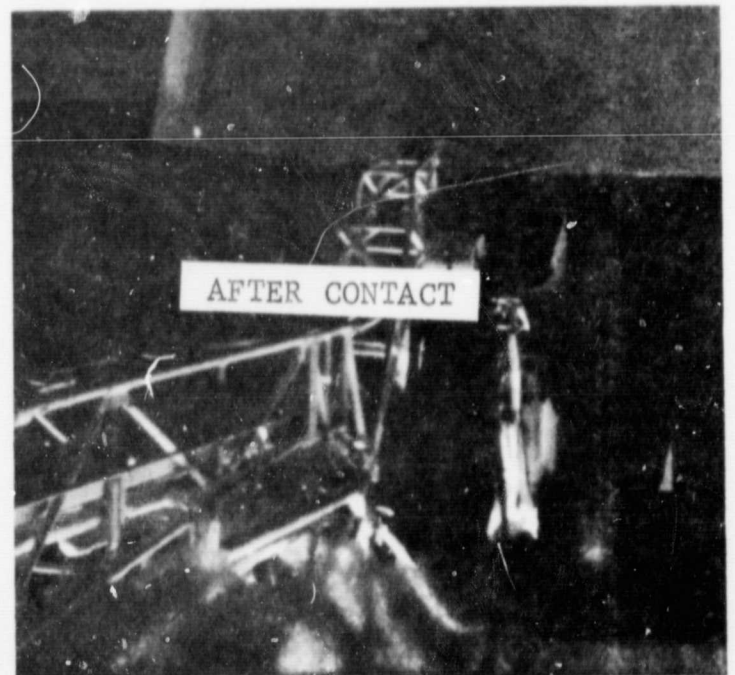
FIGURE 25. SWING ARM #3 CONTACT WITH VEHICLE COVER

Comments: Trailing wire was observed. Tank cover panel strikes face plate on arm contact mechanism. Release of arm was timed.

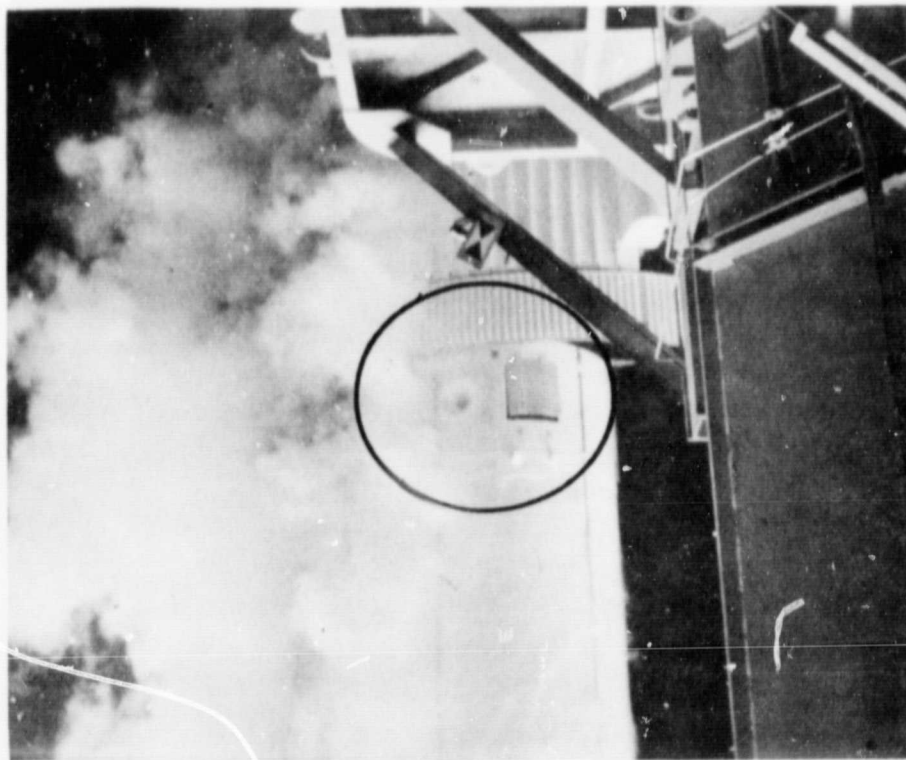
FIGURE 26. SWING ARM #1 TANK COVER PANEL OPEN

Comments: Trailing wire was observed falling through field of view. Swing arm door #1 was observed still open. Release of arm was timed.

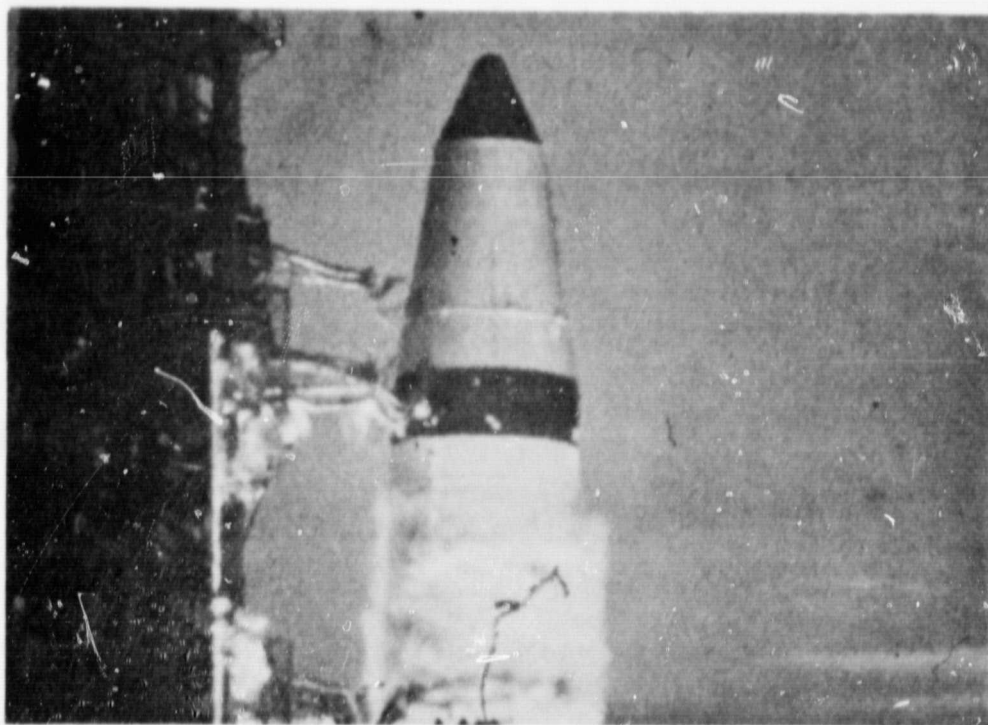
FIGURE 34. S-IVB FROST AND ICE ACCUMULATION

Three cameras were programmed to observe the S-IB/S-IVB innerstage and the S-IVB stage. The film from one camera was unusable due to poor focus. The other two cameras operated as programmed. No malfunctions were observed and no timeable events were recorded. However, an excellent view of the excess frost and ice caused by launch conditions (time, temperature, and dew point) is shown in Figure 34.

No major anomalies were observed during the launch, however, data were lost from five cameras due to the excessive frost and ice that had accumulated on the vehicle prior to launch. This is attributed to the low winds, dew point, and low radiation level at the time of launch.
